Imagery Analysis Report

Military and Insurgent Activity Svay Rieng Province, Cambodia

DDI/IAR 87001

MILITARY AND INSURGENT ACTIVITY SVAY RIENG PROVINCE, CAMBODIA

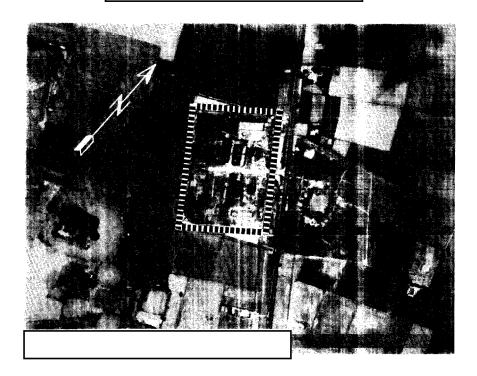
FIGURE 2

While possible army barracks is located on Cambodian Route 24, 1.3 km north of Kh Chak and LO km NNE of Svay Rieng.

The area is fence secured, covers 240,000 squire feet and contains 2 barracks/support buildings, 3 support buildings an a trench system. Conattraction was completed on one of the barracks/support buildings during une period between

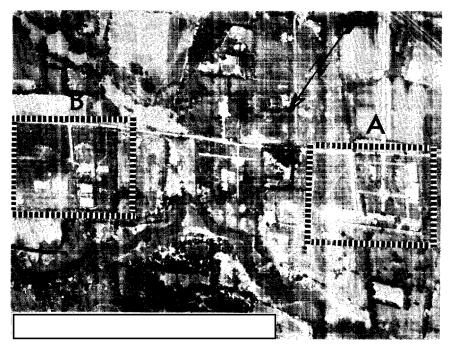
FIGURE 3

The probable army barracks is located one km east of Kh Prasot and 0.5 km north of Cambodian Route 1.

The probable army barracks is divided into two areas. Area A covers approximately 384,800 square feet and contains 2 barracks/support buildings, bupport/storage buildings and 3 support buildings. Construction was completed on one of the support/storage buildings between

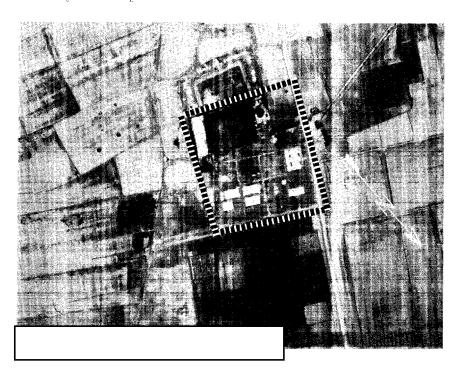
FIGURE 4

This possible army barracks is located one km north of Ph Neareaten, 15 km WNW of Svay Rieng and one km south of Cambodian Route 1.

This installation covers approximately 360,000 square feet and contains one administration/support building, one possible barracks, one secured probable storage building, 3 storage/support buildings, 2 support buildings and a vehicle repair ramp. No defenses were observed.

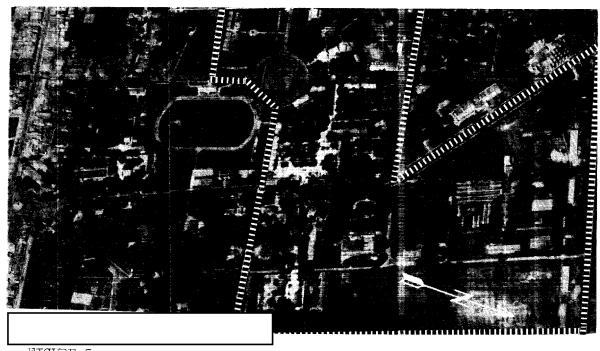
FIGURE 5

The Svay Rieng storage area is located on the eastern edge of Svay Rieng City.

This storage area is an irregularly shaped in tallation which covers approximately 3,240,000 square feet. The installation contains approximately 75 buildings including 2 administration buildings, 6 probable barracks, 10 storage buildings and at least 57 unidentified buildings. Most of the buildings in the installation are partially obscured by a heavy tree canopy which precludes a definite identification.

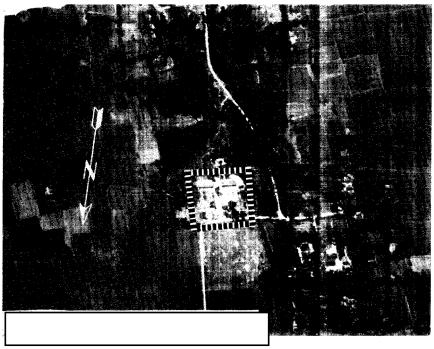
FIGURE 6

The probable storage area is located 2.5 km north of Kh Prasot and 10 km east of Svay Rieng.

The area consists of 2 probable storage buildings and an open storage area.

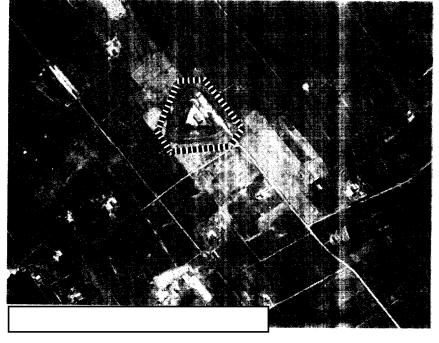
FIGURE 8

This strongpoint is located 2 km north of Ph Talok and 1.6 km south of the Cambodia/South Vietnam border.

This strongpoint is secured by an earthen wall and 2 fences and contains one administration/barracks building, one support building, one storage building, 3 automatic weapons positions, and one possible automatic weapons position.

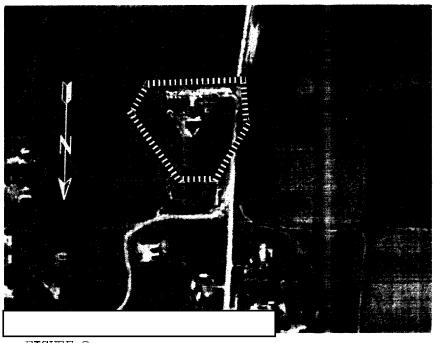
FIGURE 9

The Chantrea Strongpoint is located 2.9 km SE of Chantrea and 9 km west of the Cambodia/South Vietnam border.

The Chantrea Strongpoint is probably secured by a fence and an earthen wall. The strongpoint contains 3 buildings and at least one automatic weapons position.

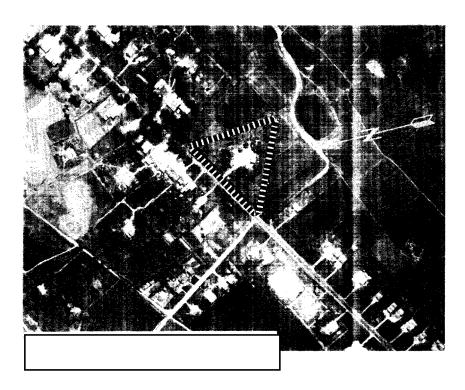
This control point is located on Cambodian Roube 1 in the village of the Bavet (2), 2.1 km ESE of the Cambodia/South Vietnam border.

The area is secured by an earthen wall and cormains 4 barracks/support buildings, one administration building and a possible guard shed at the Route 1 entrance.

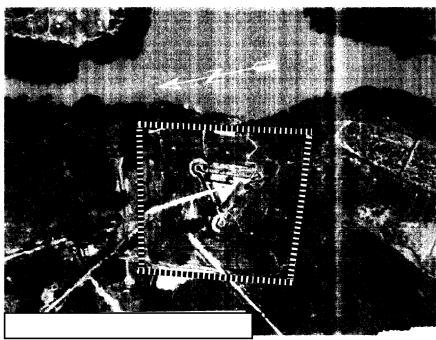
FIGURE 11

The Peam Metrey Border Strongpoint is Located mendiately west of the Cambodia/South Vietnam border at the confluence of the Prek Kampong Spean and the Each Cia Bac.

The border strongpoint is secured by 2 fences and 2 earthen walls. The strongpoint contains an administration/barracks building, 3 support buildings, 3 automatic weapons positions and 4 fexholes.

Numerous areas of extensive ground scarring served by well used trails are located immediately north of the strongpoint and adjacent to the Cambodia/ South Vietnam border.

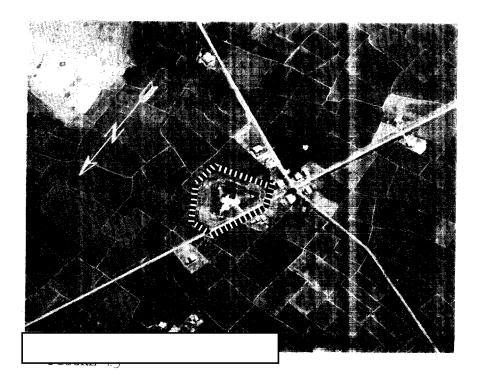
This strongpoint is located 5 km NNE of Ph Kampong Trach and 7.4 km west of the Cambodia/South Vietnam border.

This strongpoint is probably double secured by a fence and an earthen wall. It contains one administration/barracks building, 3 support buildings and 2 automatic weapons positions.

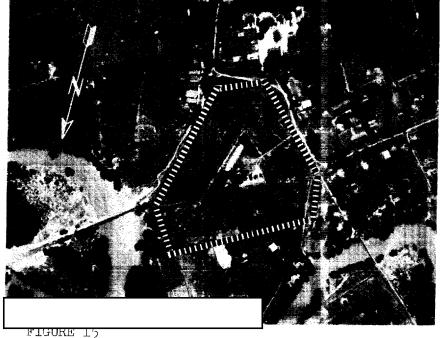
Approved For Release 2003/01/29D CHATROP79T00919A000300190001-9 IAR-87001 IMAGERY ANALYSIS SERVICE Name Phum Tamenh Strongpoint BE No. Geo. Coor: II 32 00N-105 43 15E UIM Coor: 48PWI786750 Map Ref : Sheet 6145 IV, Series L'7011, Scale 1:5 .000 (Unc.) Location The Phum Tamenh Strongpoint is located in the village of Ph Kampong Krasang il.5 km SW of the Cambodia/South Vietnam berder. Description This strongpoint is double secured by a fence and an earthen wall and eontains one barracks/administration/support building, one watchtower, 2 support buildings, 3 automatic weapons positions and a trench system. second barracks/administration/support building was dismantled

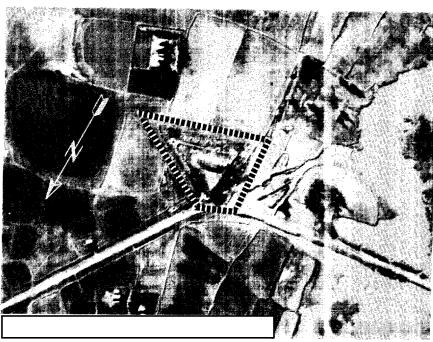
FIGURE 16

Prey Kroch Strongpoint is possibly double secured by a fence and an earthen wall. The strongpoint contains one administration/barracks building, one support building, and 4 automatic weapons positions.

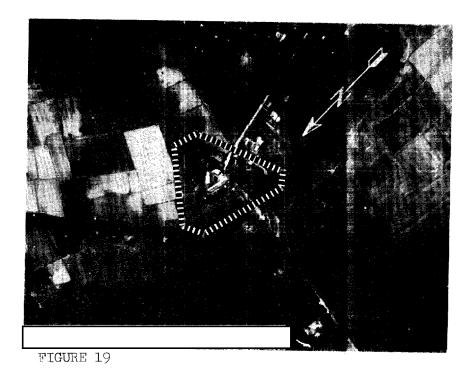
This strongpoint is double secured by an eartien wall and a fence. It contains one administration/barracks building, 2 support buildings, and 3 automatic weapons positions.

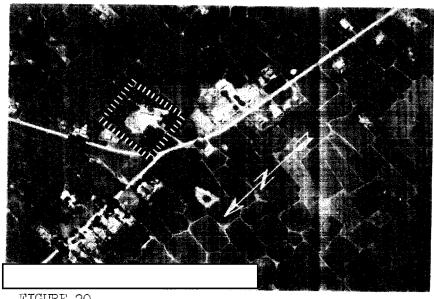
FIGURE 20

An army barracks is reportedly located immediately south of the strongpoint, but an analysis of aerial photography does not confirm this installation as being military.

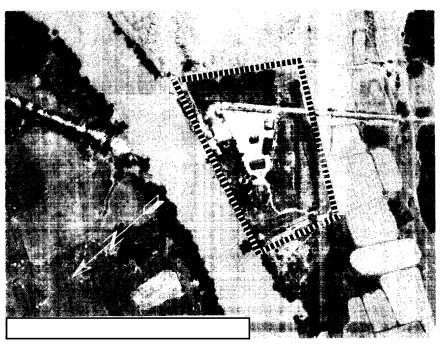
FIGURE 21

The strongpoint is possibly double secured by a fence and an earthen wall and contains θ buildings, 2 automatic weapons positions and an area of row crops.

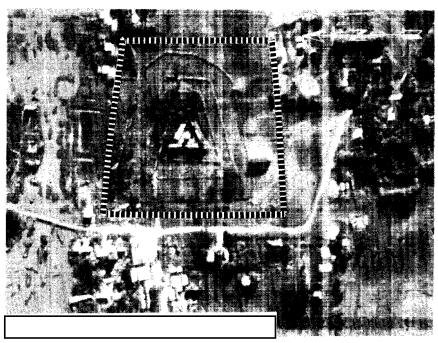
FIGURE 22

The strongpoint is completely secured by a ferce and partly secured by 3 fences which have partially deteriorated. The s rengpoint contains 2 barracks buildings, one support building, one wate bower and one automatic weapons position. A storage building, which is Lorated just outside the cutermost fence, was constructed [

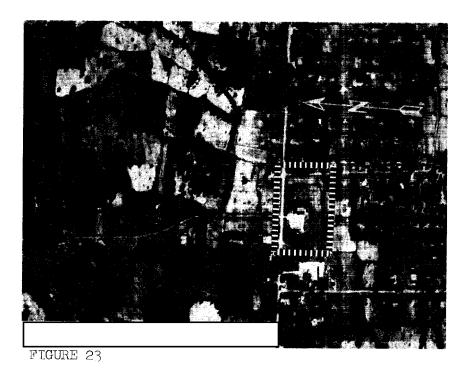
The strongpoint is completely secured by 2 earthen walls and contains one administration/barracks building, 2 support-type buildings and 3 automatic weapons positions. Immediately west of the strongpoint is a probable storage building with a trench system on the south side of the building.

A possible insurgent bivouac area is located 0.5 km north of the strong-point. Vehicle tracks are observed from the strongpoint to the possible insurgent bivouac area.

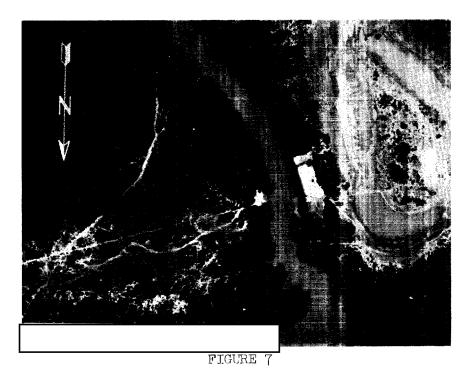
This suspect insurgent river crossing/transshipment point and bivouac area is located 3.3 km south of Ph Kampong Krasang and 0.8 km east of Cambodia Route 104. The area consists of well-used traits, vehicle tracks, and extensive ground scarring in wooded areas on boan sides of the Prek Ta Te (river). The river is navigable southeastward into South Vietnam.

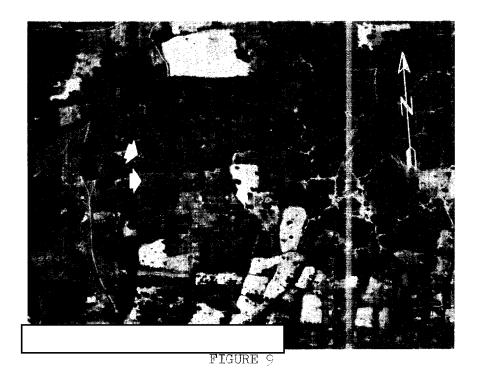
This probable insurgent bivouac area is located 0.5 km north of Ph Prey Thot and 1.5 km west of the Cambodia/South Vietnam order. Vehicle tracks, extensive ground scarring, 3 automatic weapons positions (note arrows on print), and numerous trails leading east to the bor er are noted in the area.

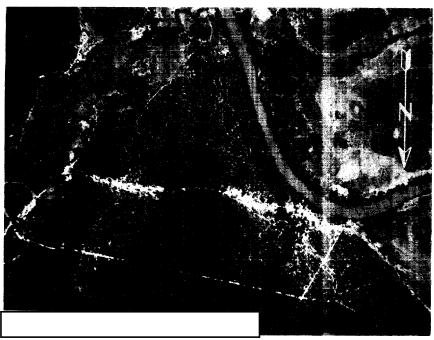
FIGURE 11

This suspect insurgent bivouac area is located in the east bank of the Prek Kampong Spean (river), 6.3 km north of Ph Kampong Trach and 11.8 km west of the Cambodia/South Vietnam border. The area consists of numerous vehicle tracks, a series of well-used trails, and extensive ground scarring in a wooded area. The Prek Kampong Spean (river) is navigable eastward into South Vietnam.

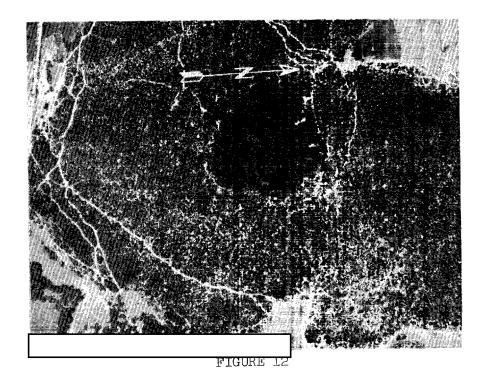
This area is located 2.4 km east of Ph Kampong Trach and 6.5 km west of the Cambodia/South Vietnam border. It consists of extensive ground scarring in a wooded area and has a series of well-used trails connecting it with the Kampong Trach Army barracks.

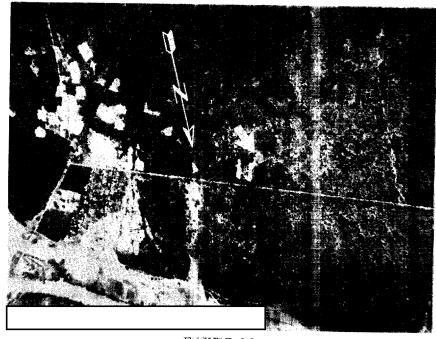
FIGURE 13

T^{α} is area is located 1.6 km west of the Cambod a/South Vietnam border and consists of a series of well-used trails, an area of row crops and extensive ground scarring in a wooded area.

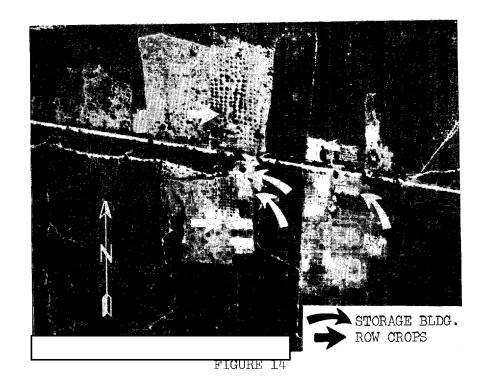
This possible insurgent storage area is located 1.4 km east of Ph Kampong Trach and 1.3 km NE of Kampong Trach Army Barracks. This area contains 3 storage buildings and 2 areas of row crops. It is connected to the barracks area by well-used trails.

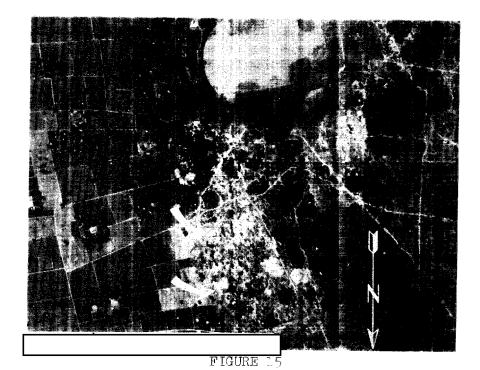
This possible insurgent base camp is located 7.3 km south of Ph Kampong Where and immed stely west of Cambodian Route 24. It consists of 7 buildings, $\ensuremath{\mathbb{R}}$ of which are secured by a fence, and several small trench systems.

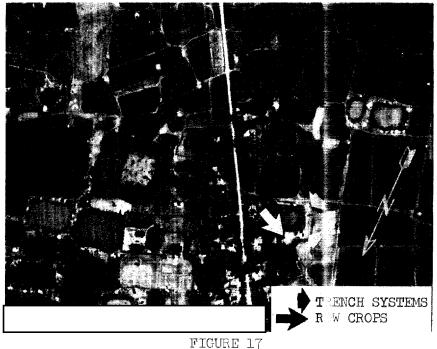
This suspect ansurgent activity is located in the village of Ph Ta Khlang on Cambodian Route 108. Two small trenches are located at the western edge of the village.

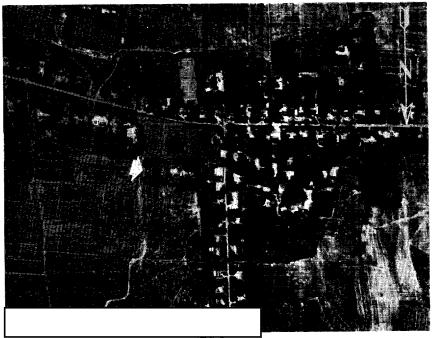
FIGURE 18

This suspect insurgent activity is in the village of Sala Khum Paraat 2.0 km north and 3.5 km west of the Cambodia/South Vietnam border. It consists of one automatic weapons position (see arrow) and extensive vehicle track activity.
